## Case 257 : Narrative

Case Vehicle (A): 1998 Plymouth	Vehicle (B): 1996 Chevrolet
Type: Breeze Expresso, 4-door sedan	Type: Blazer, 2-door 4x4
Driver: 54-year-old female	Driver: 32year-old male
CDC: 12-FDEW-2	CDC: 99-0000-0

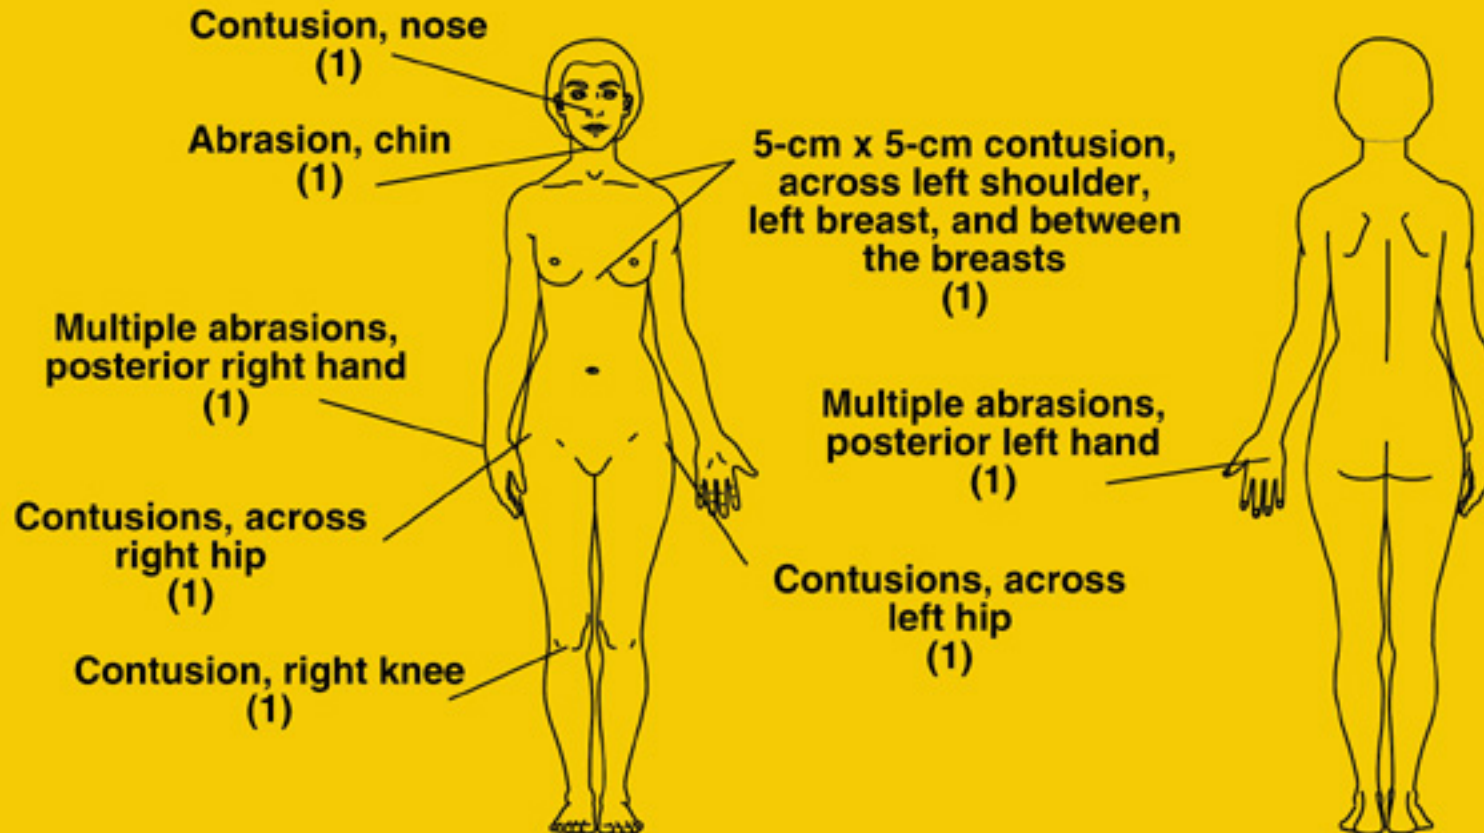
CASE NO.: 257-01

Occupant: Driver	Age: 54 years	Gender: Female		
Restraints: 3-point belt worn; airbag deployed	Stature: 170 cm (5 ft, 7 in)	Mass: 82 kg (180 lb)		
Injury Description	A.I.S.	Injury Source		
—	—	Definite	Probable	Possible
Contusion, nose	1	Airbag	—	—
Abrasion, chin	1	Airbag	—	—
5-cm by 5-cm contusion across left shoulder and left breast, and between the breasts	1	Shoulder belt	—	—
Multiple abrasions, posterior left hand	1	—	Vehicle interior/airbag fling	—
Multiple abrasions, posterior right hand	1	—	Vehicle interior/airbag fling	—
Contusions, across left hip	1	Lap belt	—	—
Contusions, across right hip	1	Lap belt	—	—
Contusion, right knee	1	Knee bolster	—	—
Maximum A.I.S. Level	1	—	—	—
Injury Severity Score	1	—	—	—

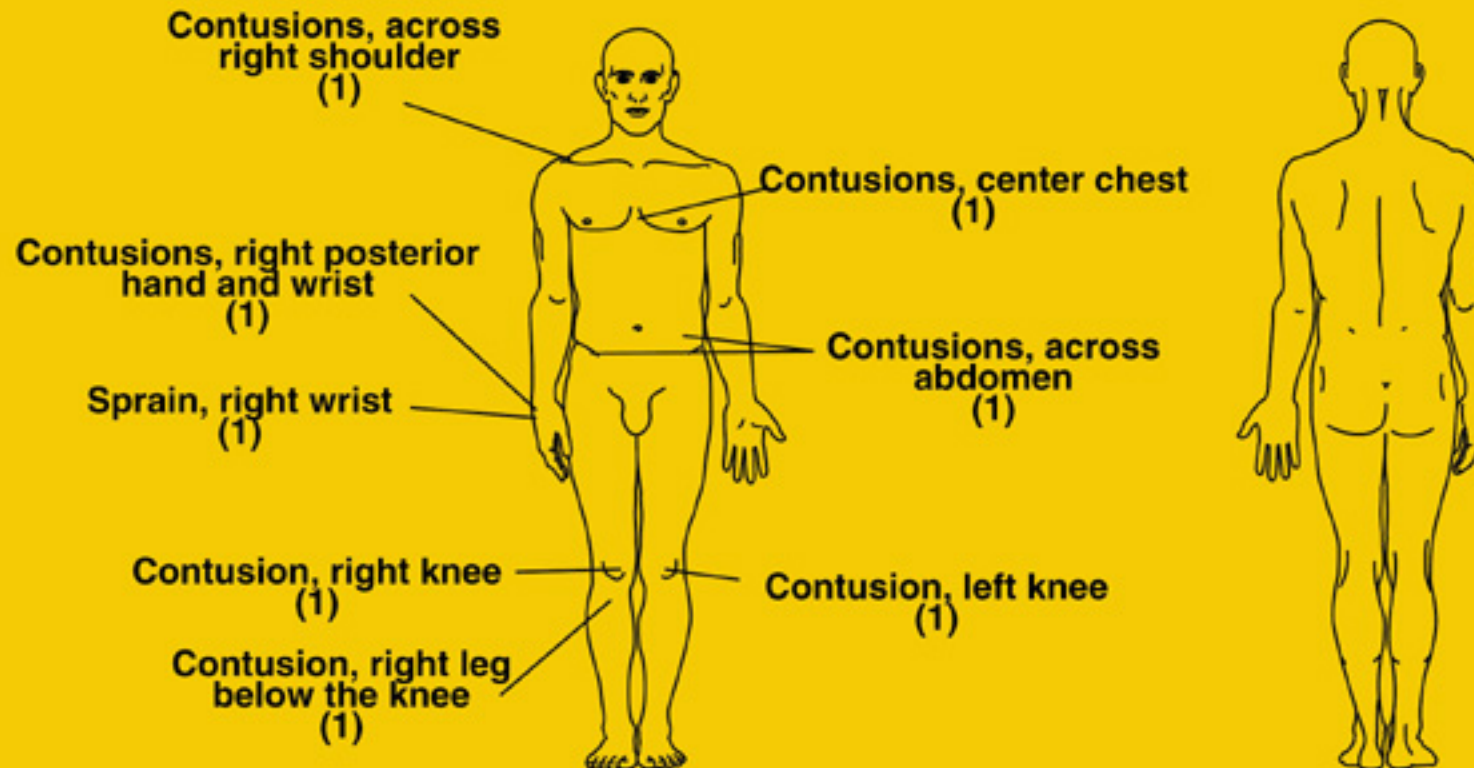
CASE NO.: 257-01

Occupant: Right front	Age: 76 years	Gender: Male		
Restraints: 3-point belt worn; airbag deployed	Stature: 188 cm (6 ft, 2 in)	Mass: 86 kg (190 lb)		
Injury Description	A.I.S.	Injury Source		
—	—	Definite	Probable	Possible
Contusions, across right shoulder	1	Shoulder belt	—	—
Contusions, across center chest	1	Shoulder belt	—	—
Contusions, across abdomen	1	Lap belt	—	—
Contusions, right posterior hand and wrist	1	—	Airbag, interior door/airbag fling	—
Sprain, right wrist	1	—	Airbag, interior door/airbag fling	—
Contusion, left knee	1	Vertical console	—	—
Contusion, right knee	1	Glove compartment	—	—
Contusion, right leg below the knee	1	Heater duct beneath the glove compartment	—	—
Maximum A.I.S. Level	1	—	—	—
Injury Severity Score	2	—	—	—

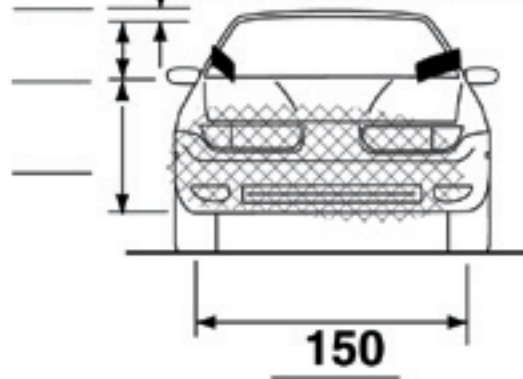
**cowl contact  
cracked windshield**

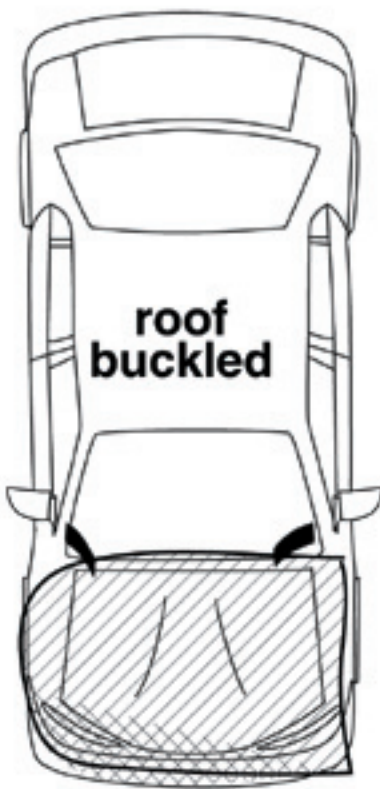
**roof  
buckled**

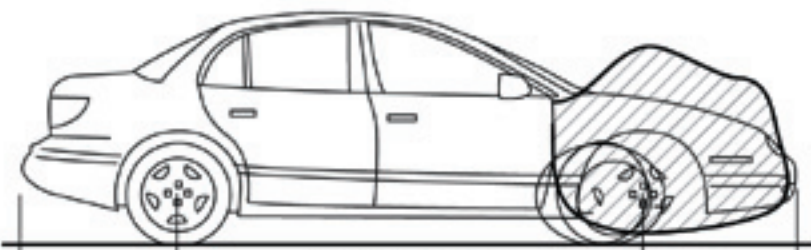
**140 cm dd  
30-cm max crush  
at C6**

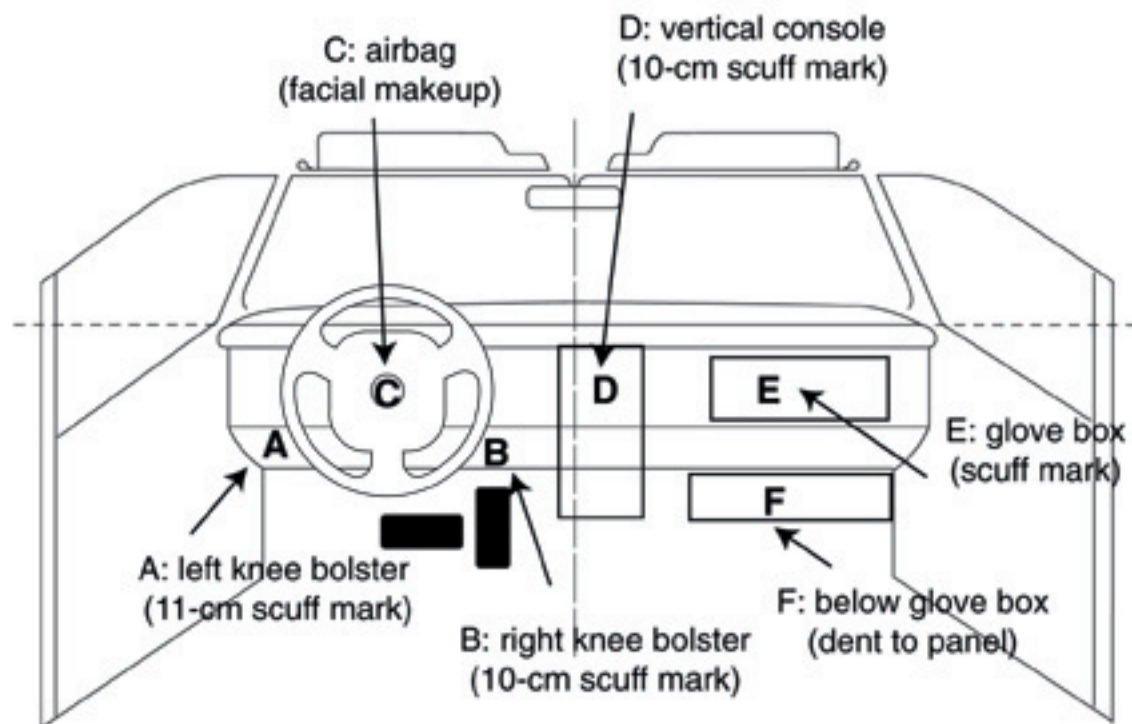
DR belt: webbing imprint on D-ring, adjusted to low position on B-pillar

RF belt: 16-cm black mark on shoulder belt webbing from D-ring, webbing imprint on D-ring, low position on B-pillar
